**NSWCCD-65-TR-2003/39** September 2003

## **SIDER Testing of Two Range Safety Craft**

SUBJ: STRUCTURAL IRREGULARITY AND DAMAGE EVALUATION ROUTINE  
(SIDER) INSPECTION OF SHIP STRUCTURES

**SIDER Testing of Two Range Safety Craft**

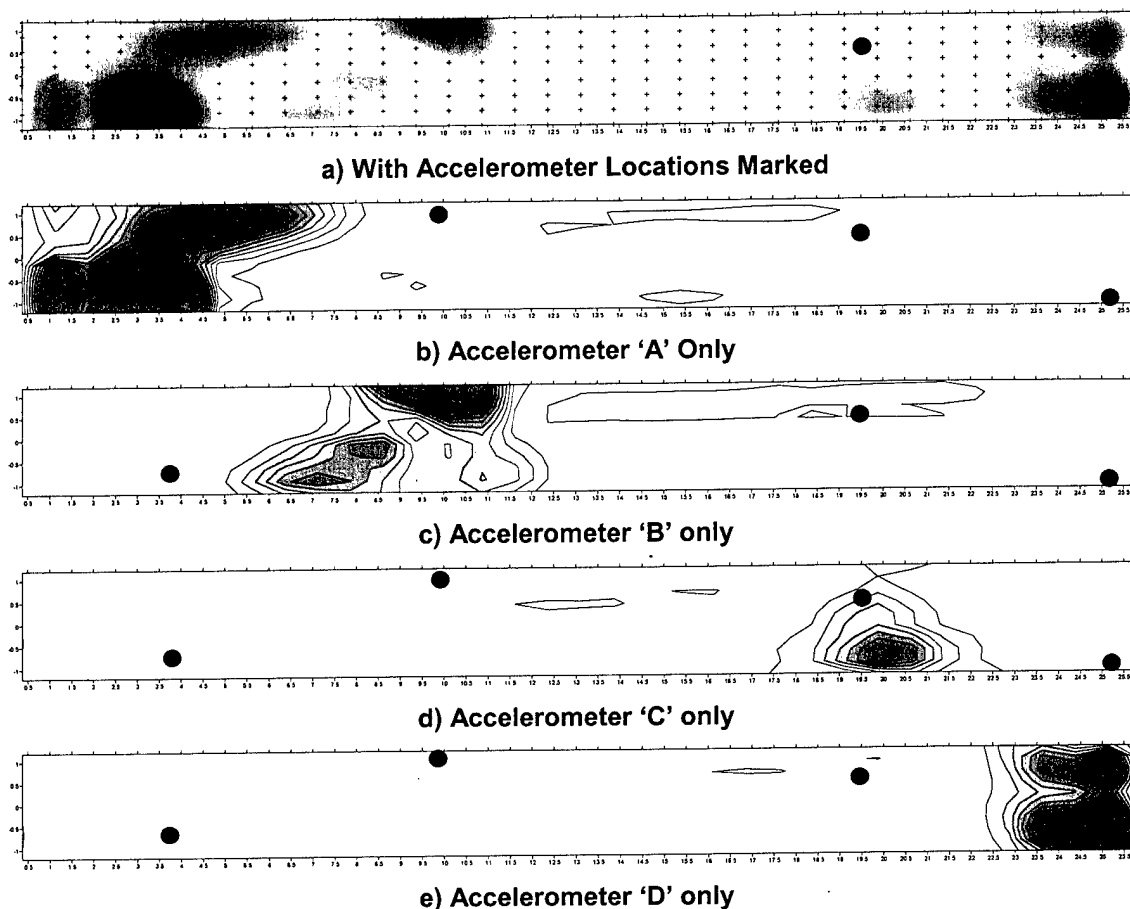
**Figure 7. Test ID R2 SIDER Results**

It is a documented aspect of the SIDER algorithm that the procedure may produce features at the locations of the accelerometers. This is a theoretical aspect, but the effect has only been observed once before, while testing a 100% rubber submarine component. The component did not comply with one structural requirement for SIDER – that the structure be resonant. Figure 7 a) shows the SIDER results for Test ID R2 with the approximate positions of the accelerometers marked with black dots. There is some concern that at least three of the features are coincident with the accelerometers. Figure 7 b) through Figure 7 e) enhance this concern by showing the SIDER results obtained by using just one accelerometer at a time. It should be noted that this single accelerometer analysis is *not* part of the documented SIDER procedure, and is used here for demonstrative and analytical purposes only.

The SIDER theory suggests that these 'accelerometer features' are only effective for about two grid points from the accelerometer location, and beyond that the results are unaffected. Therefore, it was decided to implement a blanking algorithm to see if the small hammer would provide results similar to those from the larger sledgehammer. The blanking algorithm uses data from all four accelerometers for most of the structure. However, when the analysis is near an accelerometer, the results from the nearby accelerometer are 'blanked' and the results only obtained from the other three remote accelerometers. Figure 8 shows the effect of using the algorithm for this structure. By comparing Figure 7 a) with Figure 8, it is readily seen that this accelerometer problem is solved.

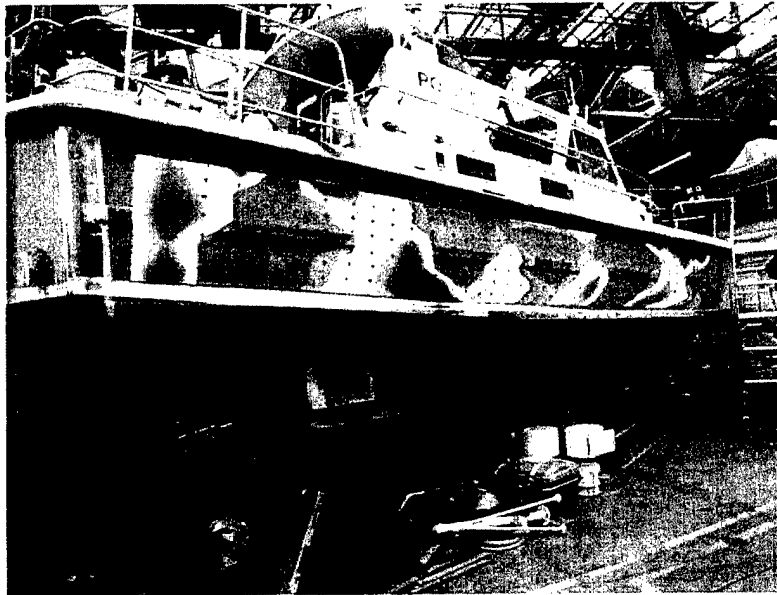
**Figure 9. SIDER Results for Test ID R1**

The two results show a remarkable agreement in both pattern of features and magnitude of SIDER values. Both tests identify the same basic regions as "clear" of irregularity. The main difference seems to be that the features identified by the small hammer are slightly larger in both magnitude and area.

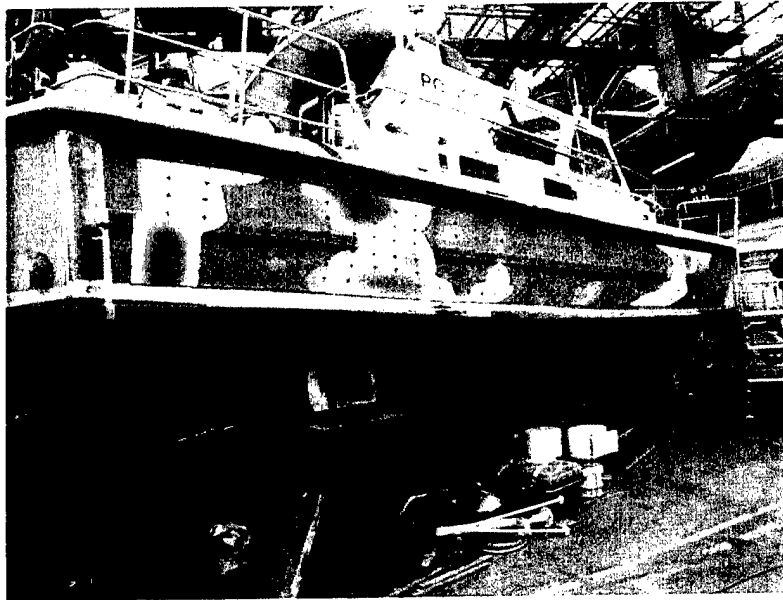
**Figure 10. SIDER Results for Test ID R2**

The two RSCs are sister vessels. There are, though, some differences. RSC Police had its starboard engine installed, whereas RSC 8126 had no engines in place. Also, there were some differences in internal attachments to the hull, and the hull penetration layouts were different. Despite these differences, the SIDER inspections have produced very similar plots of structural irregularity features. This result suggest that a baseline SIDER from one vessel may be useful in identifying problems with another hull.

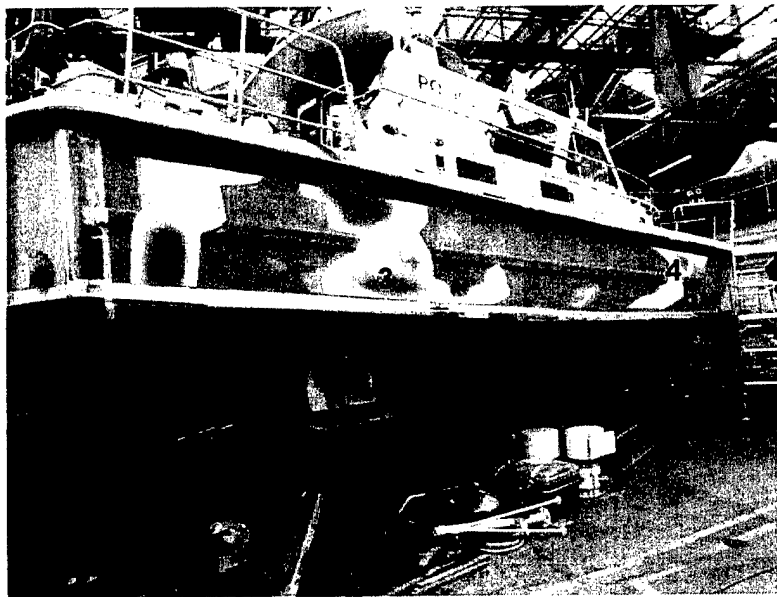
### Figure 12. SIDER Results for Test ID R2 with Marked Features

Figure 12 is similar to Figure 10, but with several features marked (the mesh has been removed from the original figure to aid clarity).

Feature 1 is coincident with an internal bulkhead. Examination of this part of the RSC Police hull by Keith Vernon, Senior Surveyor, Lloyd's Registry of London, confirmed that this SIDER feature had identified damage (probably delamination or debonding) between the main hull shell and the bulkhead. This is a high-risk part of the vessel, since it often gets hit during alongside maneuvers. There was also some nearby cracking of the internal bulkhead, but this

was not in the area that had been SIDER inspected. Mr. Vernon did note, though, that the identification of this crack was significantly aided by knowledge of the damage location identified by the SIDER analysis.

Feature 2 is strong on RSC Police, but minimal on RSC 8126. Internally to RSC Police, there is a wiring support harness at this location. It does not exist in the RSC 8126. It is speculated that SIDER has located the wiring harness, but it is possible that there is other hidden structural irregularity. The wiring harness is shown in Figure 13.

Feature 3 shows on the results for both craft. There were no obvious problems or structural features at this location, but since the feature is apparent on both RSC results, it presumably maps to some structural or damage-related stiffness variation. The thick noise and vibration lagging on the inside surface of the hull precluded a detailed investigation of this area.

Feature 4 also shows on the results for both craft. At this point inside the hull there is a small galley, and it was not possible to get to the inside surface of the hull shell. However, this is another high-risk part of the hull, prone to impact damage during alongside evolutions.
